REPORT NO. NADC-84054-60

## CHARACTERIZATION OF NEWLY DEVELOPED CONDUCTIVE COMPOSITES

L. J. Buckley, I. Shaffer, R. Trabocco  
Aircraft and Crew Systems Technology Directorate  
NAVAL AIR DEVELOPMENT CENTER  
Warminster, PA 18974

MARCH 1984

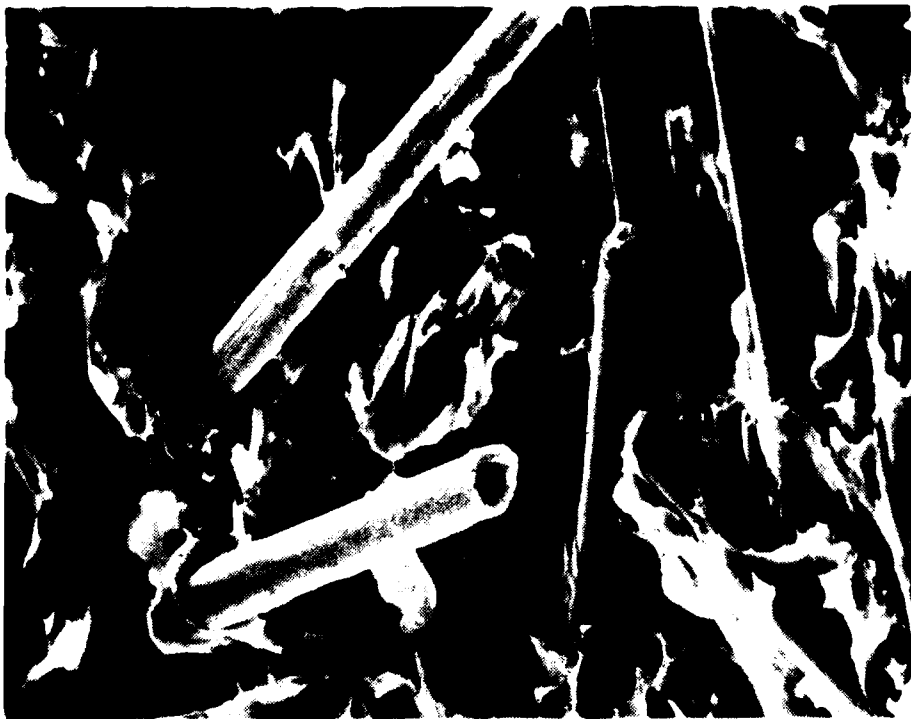
Figure 6. SEM Photographs of 20% Gr/PPS and PEI Tensile Fracture Surfaces (1000X)

Scanning electron microscopy (SEM) shows in figure 6 a comparison of the PEI and PPS# tensile fracture surfaces with uncoated Gr fibers (20%). The PEI samples show less fiber pull-out and increased fiber/resin adhesion over the PPS# samples. The nickel coating on the graphite reinforcement lowered the tensile and impact properties (see table III and figure 7). This was caused by an overall decrease in the stress transfer from the resin to the fiber by poor interfacial bonding. This was seen with SEM in figure 8 where fiber/resin bonding is compared on two tensile fracture surfaces for nickel coated and uncoated fibers. The nickel coating or sheath inhibits chemical bonding between the fiber and the resin. The small improvement in electrical properties needs to be weighed against the decrease in mechanical properties.

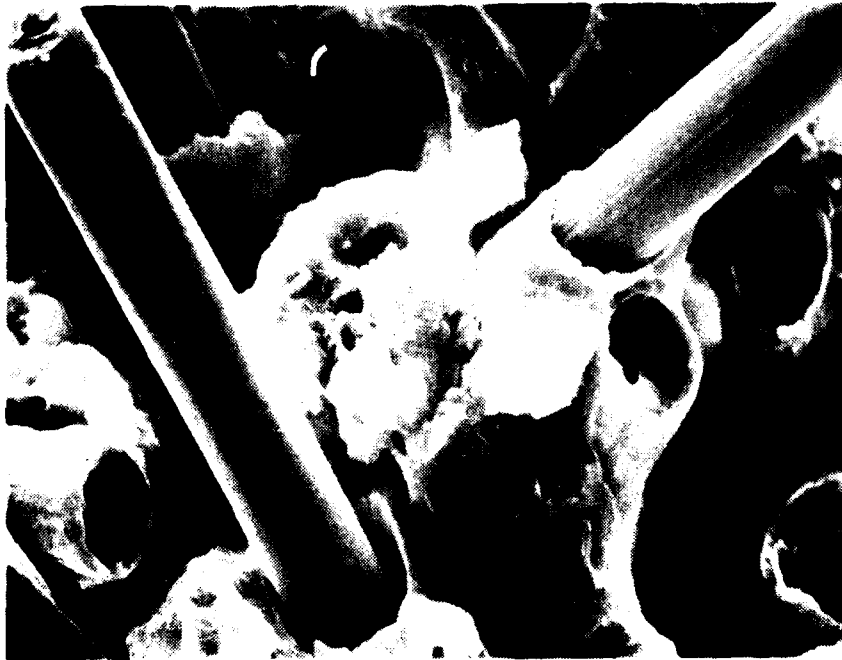
Figure 8. SEM Photographs of 40% Gr and NiGr/PPS Tensile Fracture Surfaces (2000X)
